Experimental Study on Fatigue Failure Evolution in Composite Plate Monitored by Wave Propagation Method

Adam STAWIARSKI, Marek BARSKI, Aleksander MUC
*Institute of Machine Design, Cracow University of Technology,
al. Jana Pawła II 37, 31-864, Kraków, Poland,
adam.stawiarski@pk.edu.pl, marek.barski@pk.edu.pl, olekmuc@mech.pk.edu.pl*

Keywords: fatigue failure, wave propagation, composite plate, elliptical hole

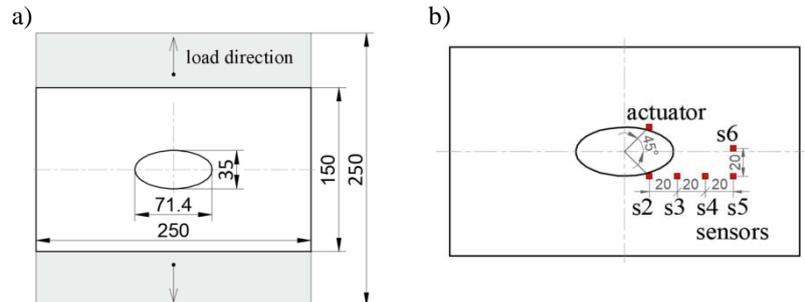
Composite plates with an elliptical shaped hole in the middle were considered. The important dimensions of the specimen with the schematically marked grips for the fatigue tests and load direction were demonstrated in Figure 1a. Figure 1b demonstrates the localization of the piezoelectric actuator and sensors.

Figure 1. a) The composite plate with an elliptical hole with marked grips and load direction, b) configuration of the actuator and sensors.

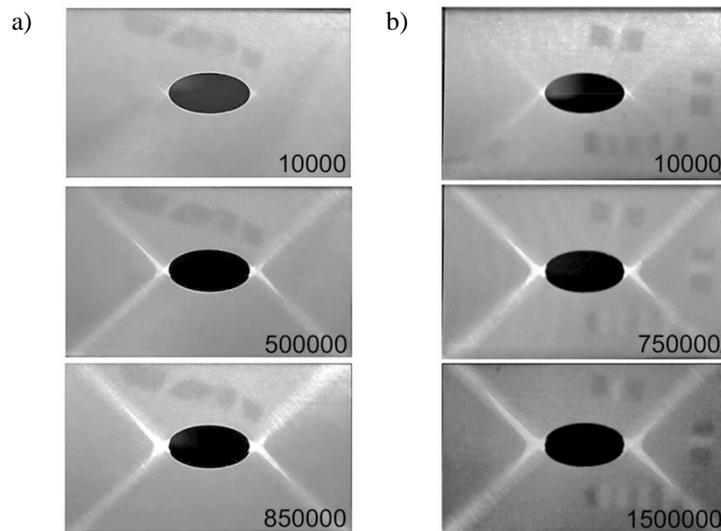
Figure 2. The failure form of the composite plates with a total number of cycles in the fatigue test equal to a) 850000 and b) 1500000.

The laminates were made of 8 layers - epoxy/glass prepreg (TVR 380 M12/26%/R-glass) having the following properties: $E_1 = 47.12$ [GPa], $E_2 = 14.61$ [GPa], $\nu_{12} = 0.09$, $\nu_{21} = 0.28$, $G_{12} = 16.03$ [GPa]. The material properties were determined in the uniaxial tension tests with the use of ASTM D 638 standard. The standard specimens (Type I) were mechanically cut off from the plates. The transverse strain was measured by electric resistance wire strain gauges. Laminates were cured in the autoclave at 135 °C for 120 min and 0,8 bar of the partial vacuum. During the autoclave process, the specimens were additionally loaded by external pressure equal to 4,5 bar. The accurately controlled production process of the laminated plates with the use of autoclave allows obtaining high quality structural components with a high volume fraction of fibers. The symmetrical composite stacking sequence was considered $-\left[\pm 45, \pm 45\right]_s$. The total thickness of the plates was equal to 2 mm. The fatigue test was conducted using hydraulic tension machine MTS 793A. The tensile loading condition was carried out. The mean loading force value equal to 38 [kN] was achieved during the quasi static tension of the plates. Then the fatigue tests were conducted with an amplitude equal to ± 4 [kN] and frequency 30 [Hz]. The fatigue loading conditions were the same for both tested specimens. Figure 2 demonstrates the exemplary failure form evolution during the fatigue tests of the considered plates. The current number of cycles is presented in each picture. The direction of the matrix splitting propagating from the hole was roughly tangential to the hole boundary.

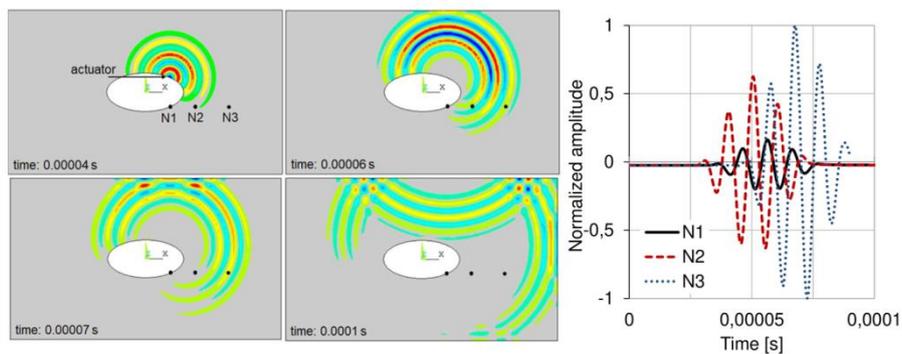
Figure 3. The numerical results of the wave propagation in the composite plate.

The influence of the hole curvature to the elastic wave amplitude can be easily noticed. Even though the measuring points N1 and N2 were closer to the actuator, the curvature of the hole caused a substantial amplitude reduction than for N3 measuring points. The separation of the elastic wave of the hole edge can also be observed which may influence on the effectiveness of the wave propagation method when the sensors are localized near the curvature of the hole.

The numerical model of the elastic wave propagation phenomenon in the analyzed composite plate was prepared with the use of the finite element method applied in Ansys package. The higher-order shell elements having six degrees of freedom per node were used in the analysis. The numerical simulation was carried out for an intact structure to observe the wave propagation in the case of a structure with an elliptical hole. The actuator was modeled as a point force in the same form as used in the experimental test. The output signal was registered as out of plane displacement component. The wave propagation phenomenon in the particular time steps was demonstrated in Figure 3. The three measuring points were defined (N1, N2, and N3) to observe the elastic wave behavior after propagation near the hole. The time of analysis has been carefully selected to ensure the propagation in the analyzed region and to avoid the influence of the reflections from boundaries on the wave propagation results.

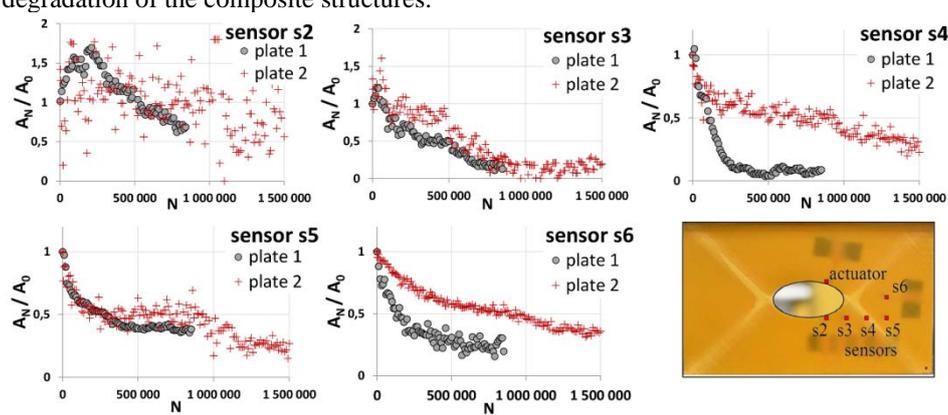
the edge of the hole. Moreover, this effect was strengthened by the initiation of fatigue damage. As it may be observed in Figure 4 the measurement of the amplitude reduction caused by the evolution of the damage during the fatigue tests was observed by all other sensors. In most cases, the first stage of the fatigue test was connected with the dynamic decrease of the amplitude. In the second part of the test, the stabilization of the amplitude reduction was visible. Such a behavior corresponds to the typical stiffness degradation of the composite structures.

Figure 4. The results of the amplitude measurement for sensors s2-s6.

The visible differences between considered plates were observed by sensor s4. It should be noticed that this sensor was placed directly on the edge of the fatigue damage. The stochastic character of the real damage evolution resulted in significant amplitude reduction.

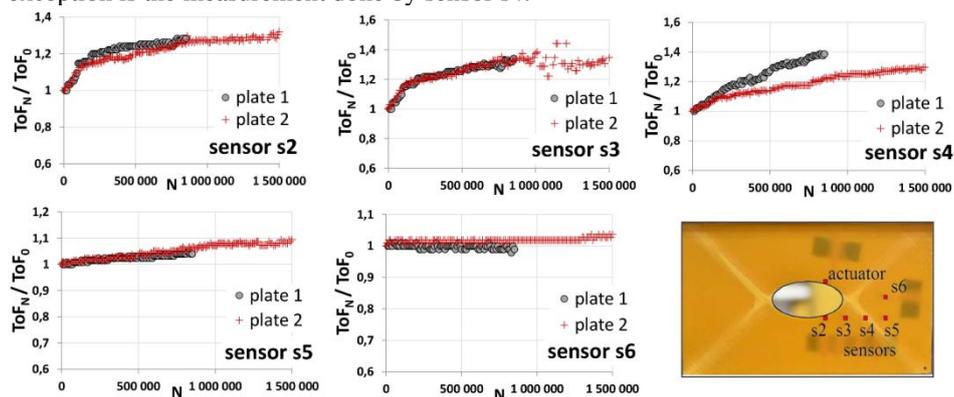
Figure 5 presents the time of flight measurement related to the ToF parameter at the beginning of the tests. The effect of the ToF increase during fatigue tests can be noticed. The good agreement of the ToF measurement in both analyzed plates was achieved. The exception is the measurement done by sensor s4.

Figure 5. The results of the time of flight measurement for sensors s2-s6.

What is interesting the increase of the ToF parameters for sensors s5 and s6 was lower than for sensors s2 or s3. It may be caused by the mutual position of the actuator and particular sensors, the level of the damage evolution, or the deformation of the plate during the fatigue test. Nevertheless, the presented results proved that the wave propagation method can be an efficient tool for damage detection and monitoring of the failure form evolution in the composite structures.
